# **Notice of Preparation**

PROJECT NAME: Elmway Levee Rehabilitation, Okanogan County, Washington

Interested parties are hereby notified that the U.S. Army Corps of Engineers, Seattle District (Corps) plans to prepare, pursuant to the National Environmental Policy Act (NEPA), an environmental assessment (EA) for proposed levee repairs to the Elmway Non-Federal Levee, constructed along the right bank of the Okanogan River upstream of Okanogan, Washington.

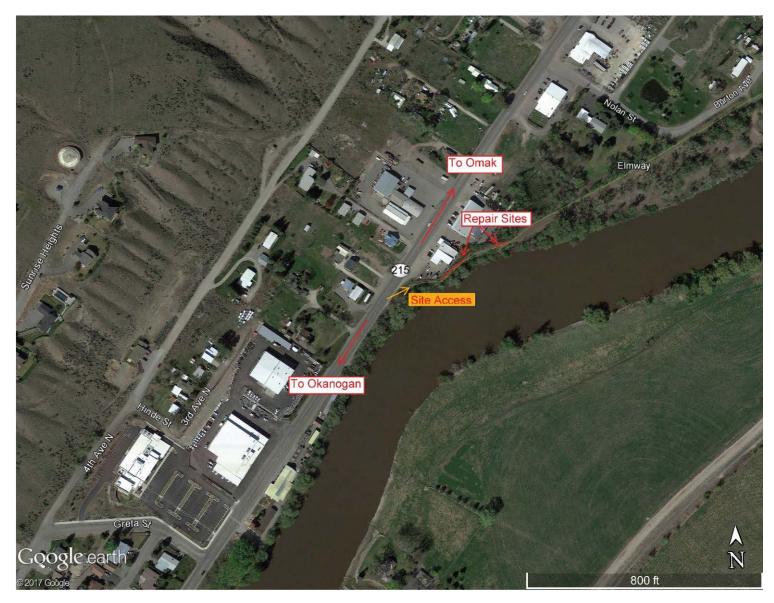
Figure 2. Damaged Sections (repair sites).

The May and June 2017, high river flows in the Okanogan River resulted in erosion of the levee slope and toe, including loss of riprap and embankment material up to several feet above the water level. The approximate area of missing material is rectangular in shape, 25 feet high and 5 feet wide. The damage is in two discontinuous sites (Figure 2), referred to as Site 1 and Site 2, which are downstream and upstream, between levee stations 1+00 to 2+50 and 4+00 to 4+50 respectively. In the damaged state, the level of protection is diminished from 2 percent (50-yr) to 33 percent (3-yr) ACE. The total length of repair, including construction tie-ins at each end of each site, is approximately 200 feet. If the levee were to fail, a number of structures (commercial and residential) could be flooded and public infrastructure (roads, power, water, and septic sewer systems) could be damaged. The Corps has not received any reports of lost lives in previous floods, an indication of a well-informed population at risk; however, the risk of loss of life still exists.

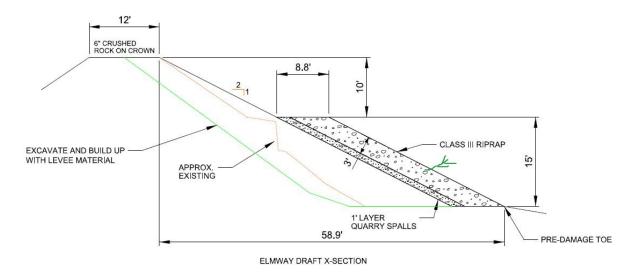
Figure 3. Typical cross-section of proposed levee repair, with willow lift at OHW.

- d) Repair in Kind Alternative. The Repair in Kind Alternative would restore the levee to preflood level of protection. The toe would be reconstructed in the pre-damage toe location using Class III riprap. The damaged slope would be re-armored with a 3-foot thick blanket of Class III riprap placed over a 12-inch layer of quarry spalls (Figure 3). The upstream and

downstream ends would be smoothly transitioned into the existing slopes. Work would require removal of approximately 25 trees (predominately mountain alder, 4-8 inches Diameter Breast Height (DBH), and 2-3 larger alders 8-12 inches DBH)) and shrubs (mix of alders, wild rose, and red osier dogwood). Anticipated environmental conservation measures are included in the project. All repairs would occur within the pre-damage footprint. Total construction length would be approximately 200 LF. Willows (Salix spp.) stakes would be planted at the ordinary high water (OHW) line. The repair work is expected to take 4 to 6 weeks to complete.

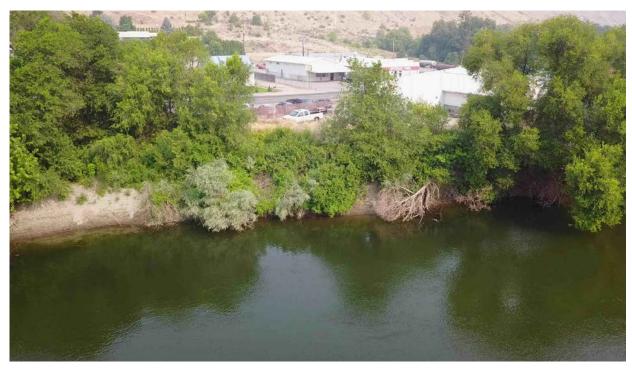
Figure 4. Okanogan River, looking upstream towards the damaged area (Note heavily leaning trees and shrubs).

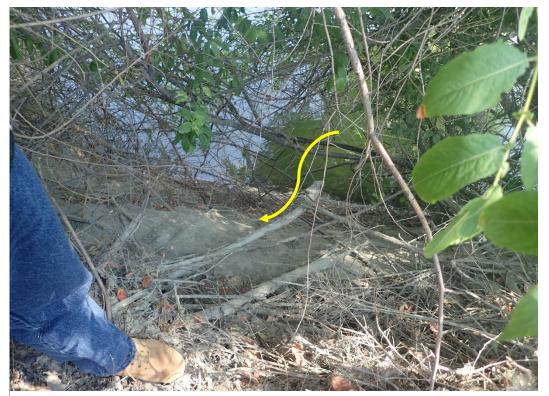
Figure 5. Damaged levee section, showing steep slope of remaining levee (top-down view).

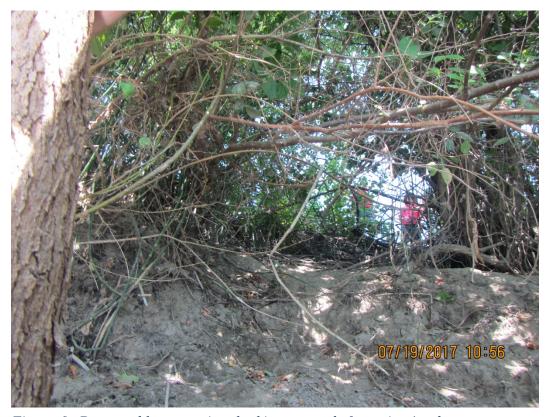
Figure 6. Damaged levee section, looking upwards from river's edge.
